# Manhole Inspection Summary

Manhole # S05AA1011MH

Insp Date: **7/16/07 9:10 AM**

**Location** Address: **3705 GARRISON BLVD**

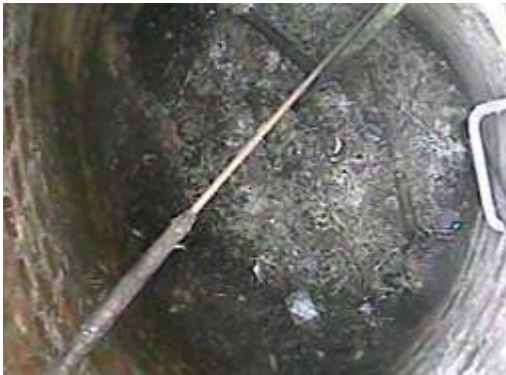
Top View

DEBRIS ON CHANNEL

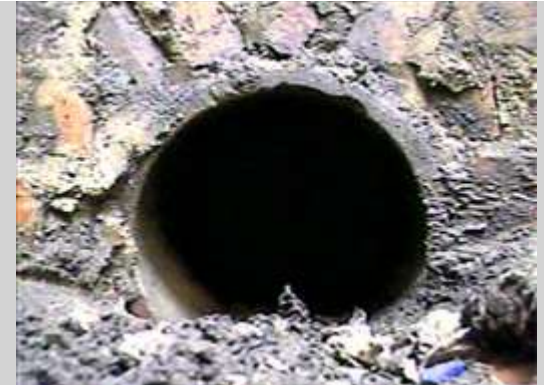
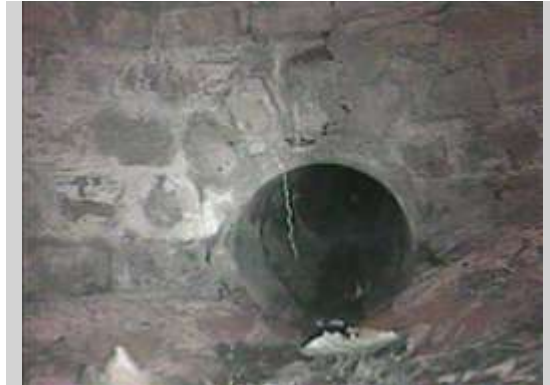
8 in. Circular Gravity Sewer  
Pipe Out @ 12 O'Clock

Infiltration: **None** Pipe Seal Cond: **Broken**
